# Manhole Inspection Summary

Manhole # S17MM1002MH

Insp Date: **12/2/06 10:36 AM**

**Location** Address: **4701 GREENSPRING AVE**

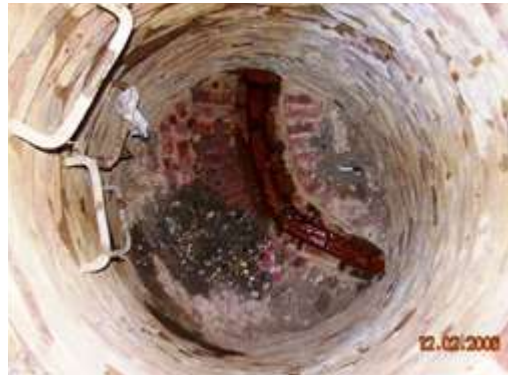
Top View

Barrel infiltration. Corroded steps.  
Evidence of surcharge - Bench debris.

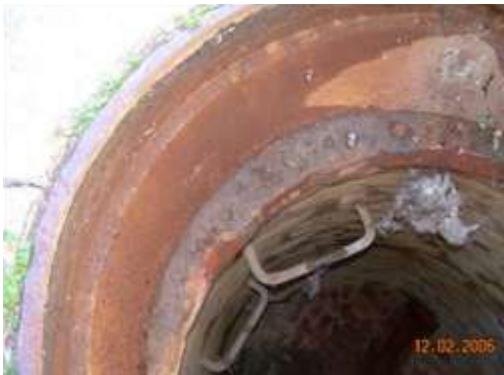
Defect

Frame leaks. Frame offset. Adjustment  
deterioration and infiltration.

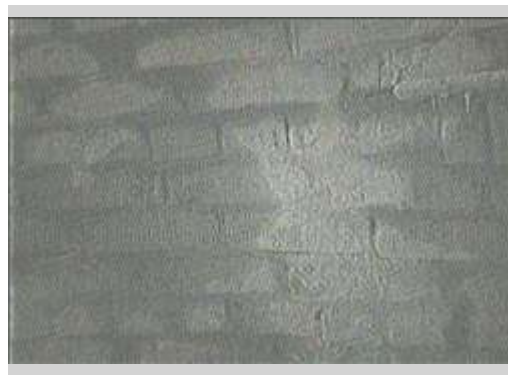
Defect

Corbel and Barrel infiltration.

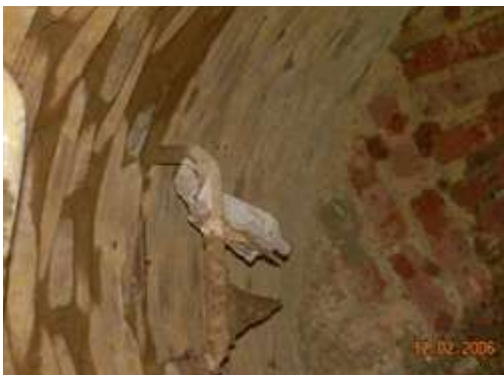
Defect

Evidence of surcharge.

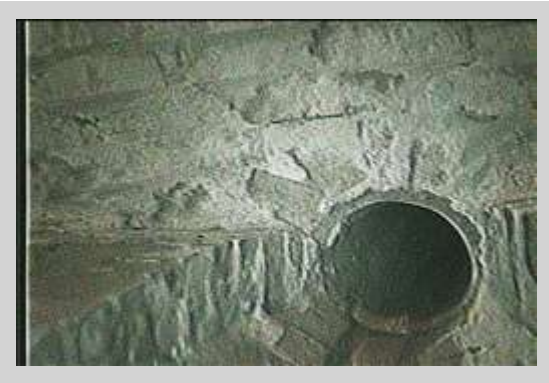
### 8 in. Circular Gravity Sewer Pipe Out @ 12 O'Clock

Infiltration: **Evidence** Pipe Seal Cond: **Unknown**

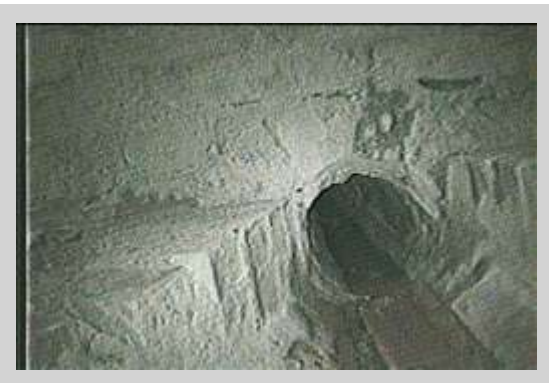
### 6 in. Circular Gravity Sewer Pipe In @ 4 O'Clock

Infiltration: **Evidence** Pipe Seal Cond: **Unknown**
